Torsten Fischer of Krieg + Fischer Ingenieure discusses an investigation related to deficiencies of several solid input devices (solid feeders) at two biogas plants in central Germany

First-person sleuthing, investigation of a silage plate

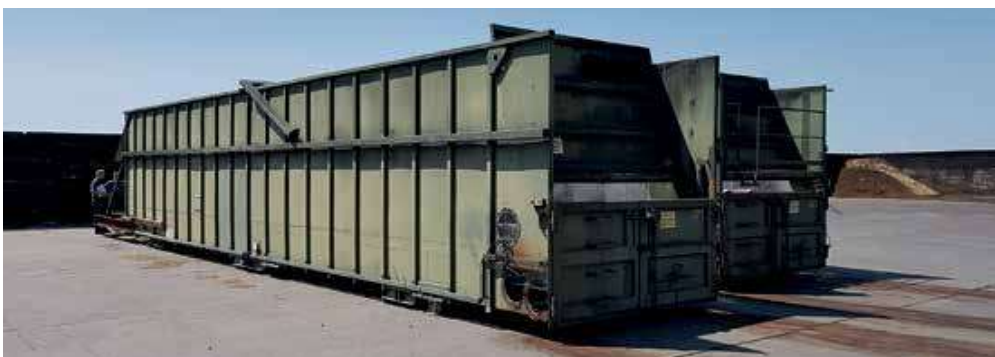
My first visit in summer 2020 gave me an impression about the general situation on site. At that time the four old SIDs had already been replaced. Figure 1 shows SIDs 1 and 2, already discarded.

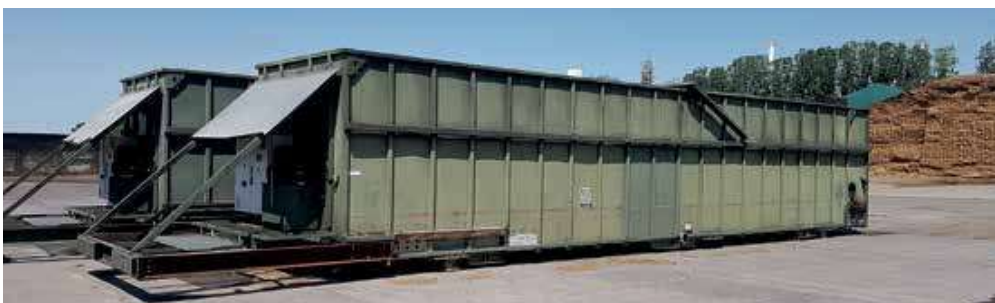
Figure 2 showed an example for the ‘steel works’. The

steel works included the addition of stiffeners and exchange of corrosive steel plates. Figures 3 and 4 provided an example of the problems the operator faced inside the containers. On the bottom of the container is a moving floor that shifts the silage. In order to keep the moving floor adjusted, there are guide rails on both sides. Over the time silage was collected in the gap between the wall and the guide rail, which compacted and bent the guide rail. This finally led to breaks in the steel construction of the moving floor and partly destroyed the hydraulic system. An example of the massive damage of the hydraulic system is shown in figure 5.
